THE LIFE CYCLE OF YOUR ROOF

Homeowner's Guide:
What to Expect
From Your
CertainTeed Roof

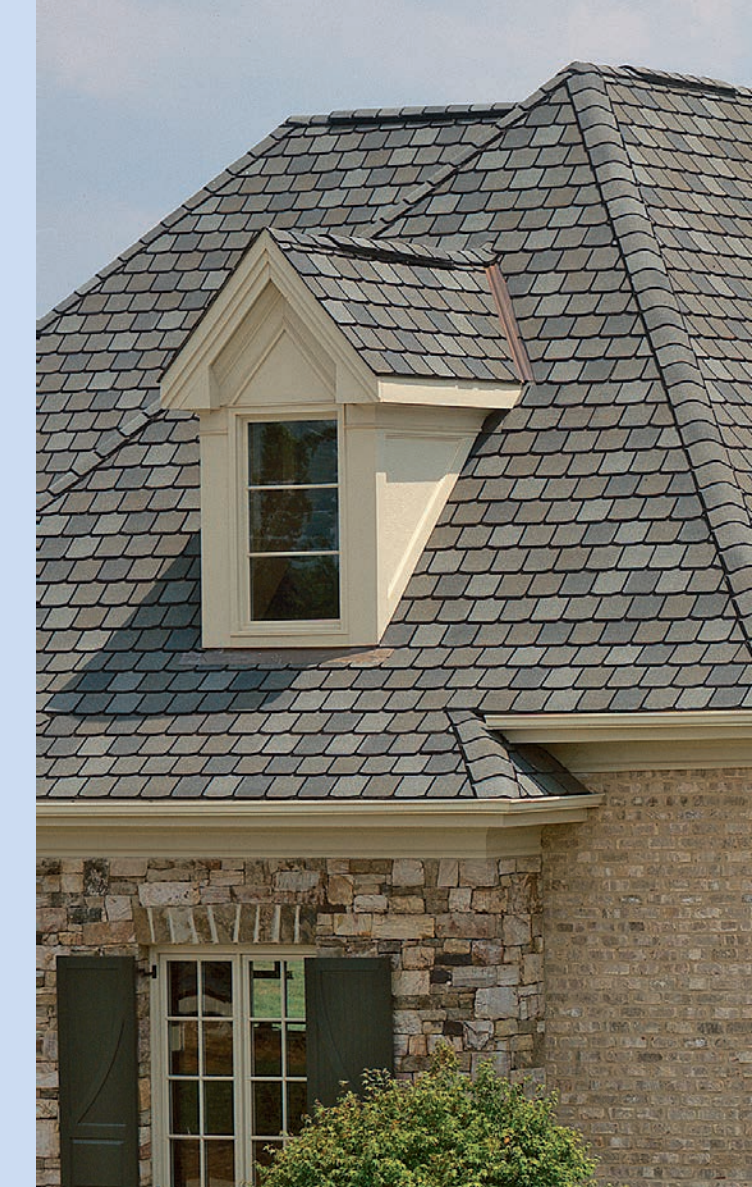
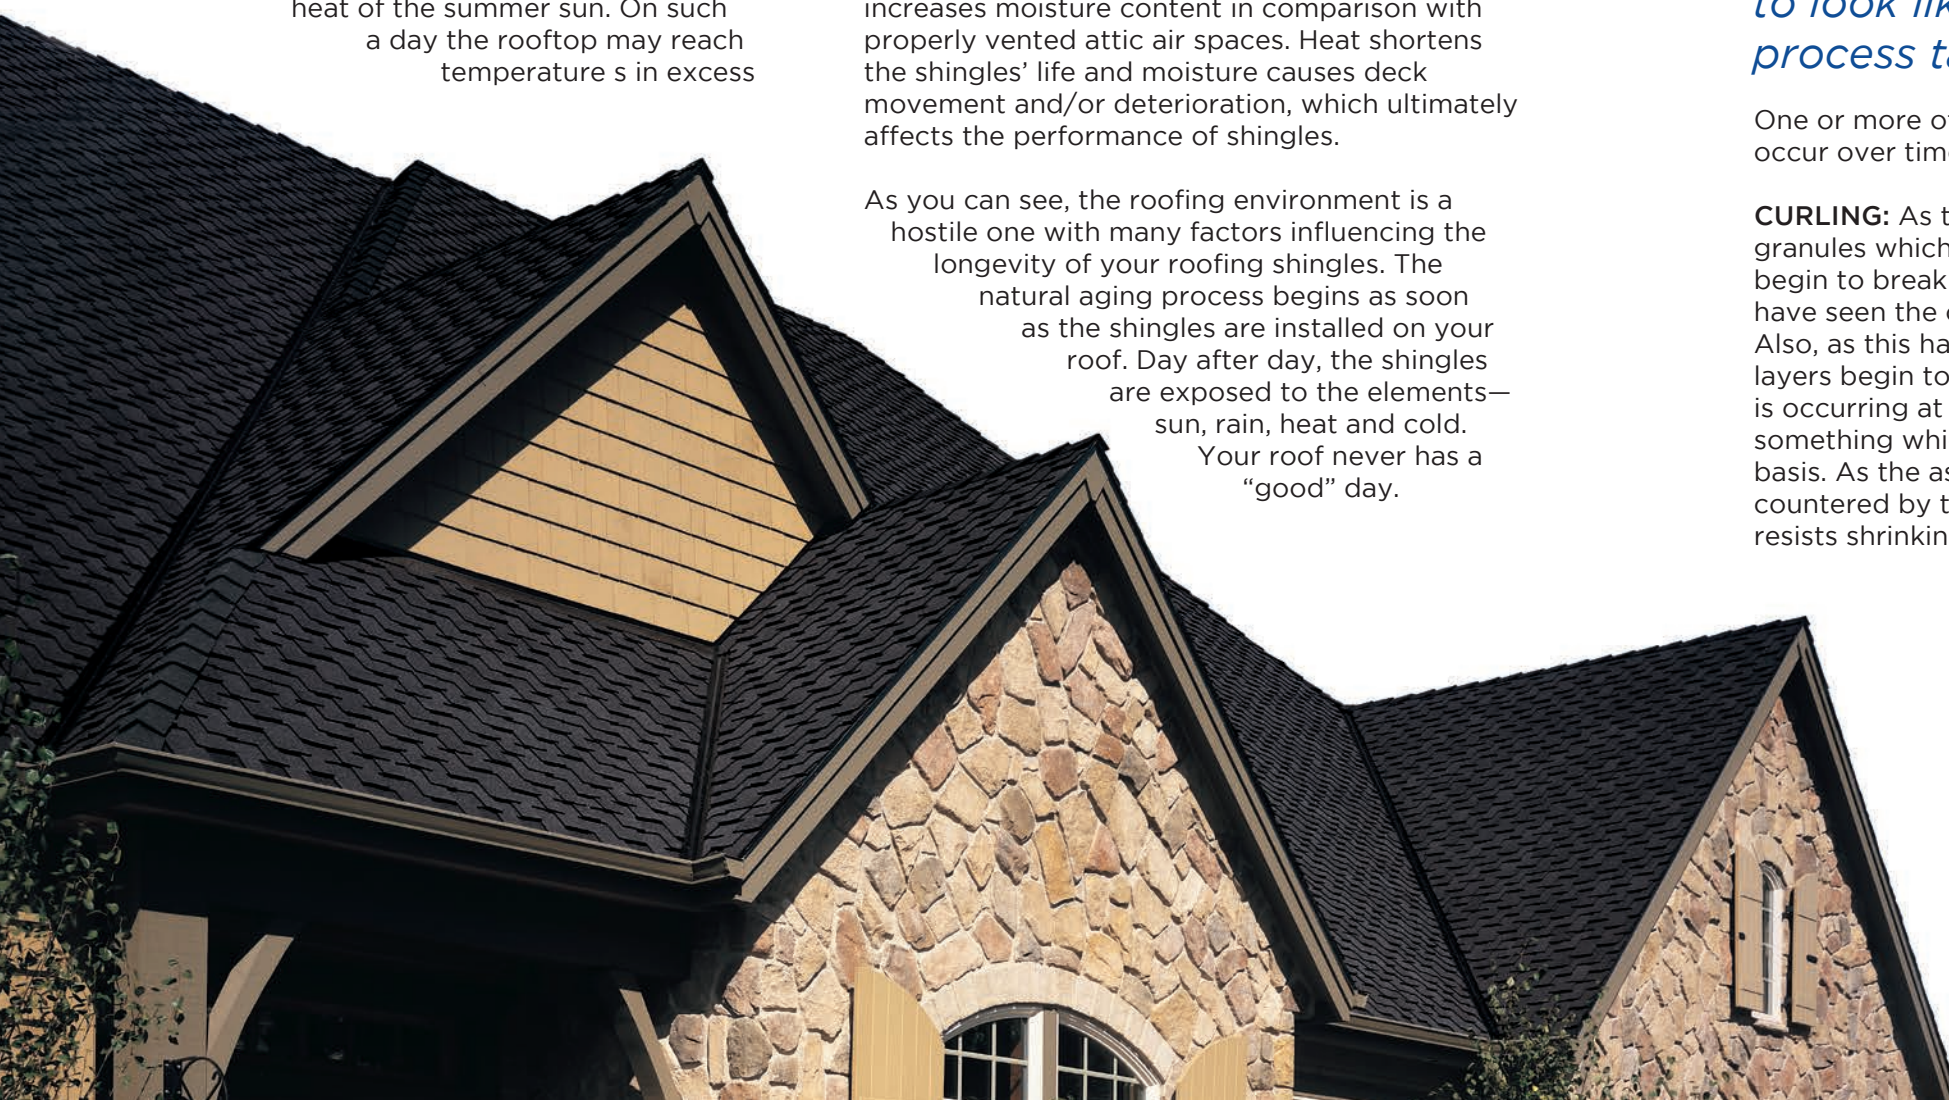
CURLING

which the top and bottom coatings are shrinking and the reinforcement is remaining stable. As a result, the edges of the shingle may begin to curl over time. In addition, organic shingles may exhibit signs of curling which might be considered excessive, however, this is not a manufacturing defect and would be considered part of the normal weathering process of organic shingles.

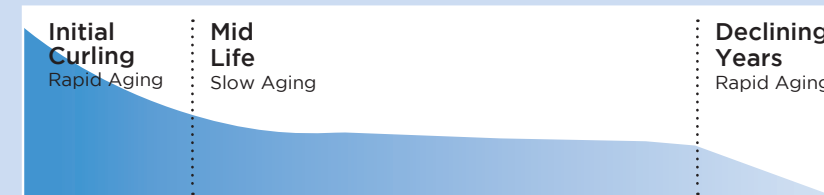
THE LIFE CYCLE OF A ROOFING SHINGLE

When your new roof was installed, friends and neighbors may have remarked how it enhanced the beauty of your home. However, research indicates that aging begins soon after the shingles are installed and progresses rapidly during the initial curing phase of its life cycle. During this stage, granule loss may occur, small blisters may develop, or the shingles may curl slightly at their edges. You may even notice that this curling is more pronounced during cold weather and the shingles may lie flat as temperatures rise. The good news, however, is that after this curing stage the shingles enter a long period of slow aging, which lasts for the major portion of the shingle's natural life.

During the "mid-life" period, aging continues at a much slower rate. The cracking or granule loss still occurs but does not increase at a noticeable rate. Only after this long period of mid-life does the aging process begin to accelerate once again as the shingles enter their declining years. It's during this period that homeowners normally think about replacing their roofs.

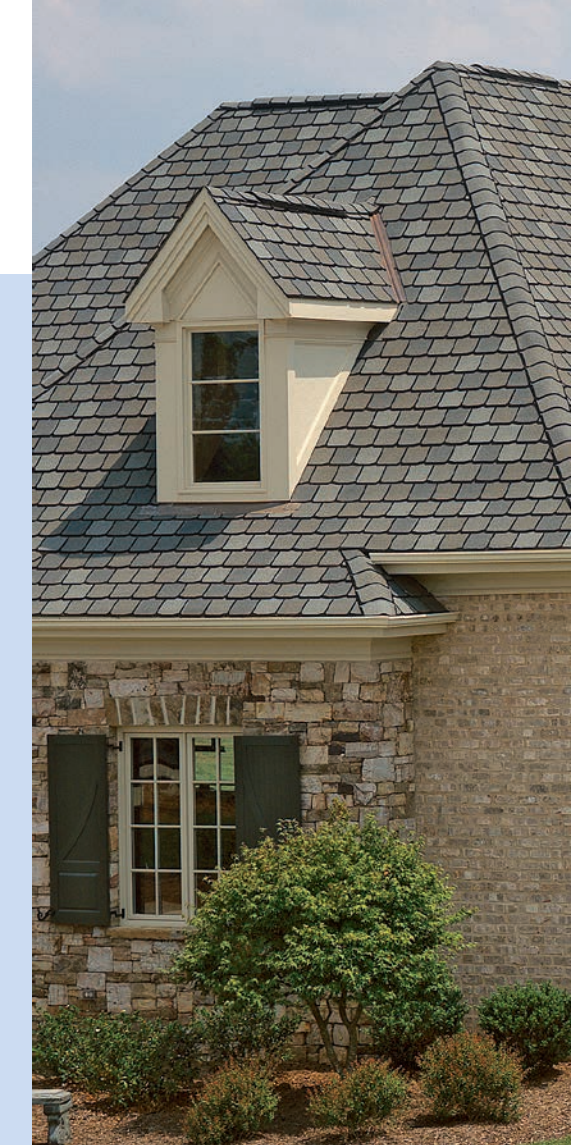
CURLING

which the top and bottom coatings are shrinking and the reinforcement is remaining stable. As a result, the edges of the shingle may begin to curl over time. In addition, organic shingles may exhibit signs of curling which might be considered excessive, however, this is not a manufacturing defect and would be considered part of the normal weathering process of organic shingles.

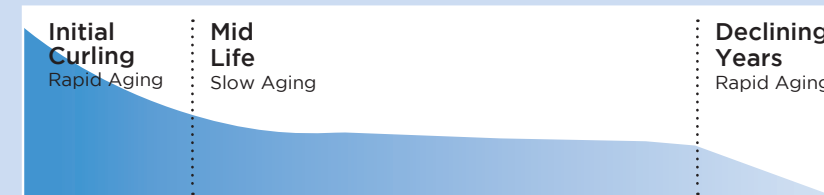
THE LIFE CYCLE OF A ROOFING SHINGLE

When your new roof was installed, friends and neighbors may have remarked how it enhanced the beauty of your home. However, research indicates that aging begins soon after the shingles are installed and progresses rapidly during the initial curing phase of its life cycle. During this stage, granule loss may occur, small blisters may develop, or the shingles may curl slightly at their edges. You may even notice that this curling is more pronounced during cold weather and the shingles may lie flat as temperatures rise. The good news, however, is that after this curing stage the shingles enter a long period of slow aging, which lasts for the major portion of the shingle's natural life.

During the "mid-life" period, aging continues at a much slower rate. The cracking or granule loss still occurs but does not increase at a noticeable rate. Only after this long period of mid-life does the aging process begin to accelerate once again as the shingles enter their declining years. It's during this period that homeowners normally think about replacing their roofs.
